# Precis Schedule of Condition

## Wotton House

Horton Road, Gloucester GL1 3PT

**Report Date: 4 February 2016**

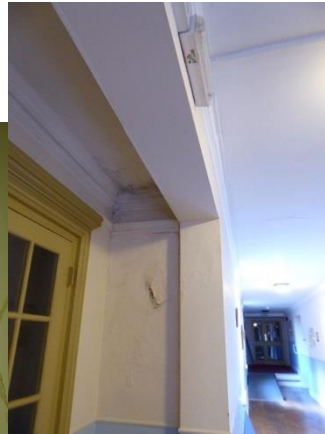
76

Pertinent Points - Internal					
Item	Location / Element	Description	Condition	Condition Category	Photograph No
Roof structure	1771 Wing - Main Reception / Admin	Roof timbers part visible in upper attic rooms. Roof timbers appeared in generally good to fair condition and in a form expected for a property of this age.	Fair	F	63
	1931 Wing	It was not possible to access roof voids	NI	NI	
Ceilings	1771 Wing - Main Reception / Admin and 1931 Wing	Ceilings expected to be decorated plasterboard and decorated lath and plaster to older areas and suspended ceilings to refurbished areas. The ceilings were generally in good to fair condition. There was evidence of minor cracking however there was no evidence of major movement or deflection to ceilings	Fair	F	66 to 70
		The ceiling to the Lecture Hall corridor was in poor condition due to water ingress. Remedial repair will be required when there is confirmation the defect allowing water ingress is remedied.	Poor	P	75

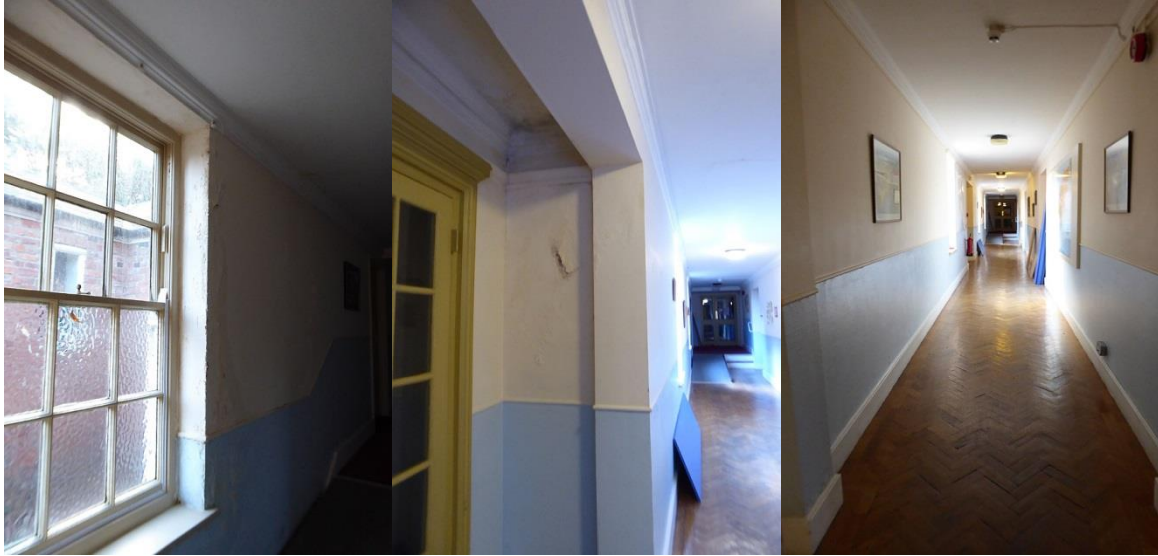
The walls to the Lecture Hall corridor were in poor condition due to water ingress. Remedial repair will be required when there is confirmation the defect allowing water ingress is remedied.	Poor	P	80 to 82
Floors	1771 Wing - Main Reception / Admin and 1931 Wing	Floors generally in good condition. The main entrance floor has original ornamental black and white stone flags in worn condition as expected for a building of this period. The floor was uneven in areas however it was not unsafe. Carpeted floors are in fair to good condition. Vinyl covered floors in fair to good condition. There is timber block flooring to the lecture room area. This floor was in fair to good condition.	Fair	F	64 to 65 82 51
Built-in fittings (not including appliances)	1771 Wing - Main Reception / Admin and 1931 Wing	Built in fittings appeared in fair to good condition with no obvious defect.	Fair	F	52
Woodwork (for example, staircase and joinery)	1771 Wing - Main Reception / Admin and 1931 Wing	Woodwork was generally in fair to good condition. The stairs to the 1771 wing were an ornate feature in good condition.  The side stairs to the attic offices may be considered a risk due to the lack of barrier from adjacent room to the top of the stair.	Fair	F	52  61

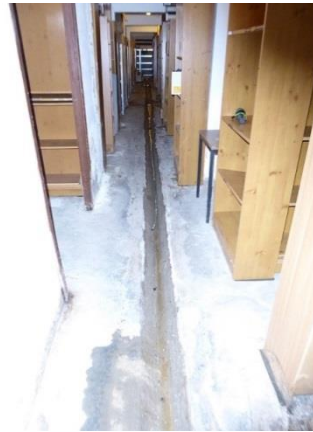
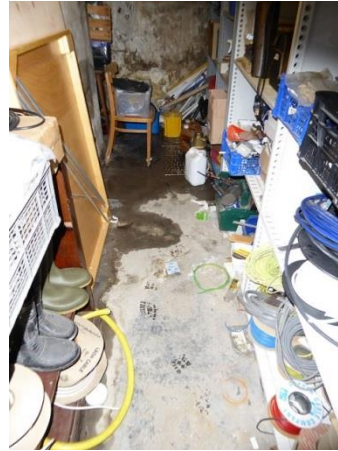
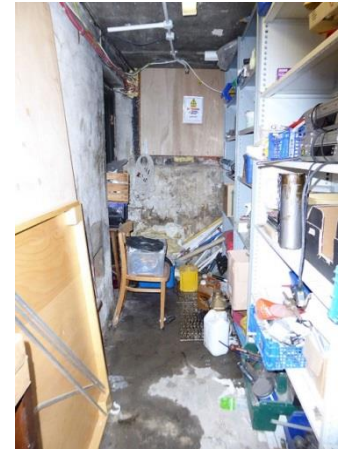
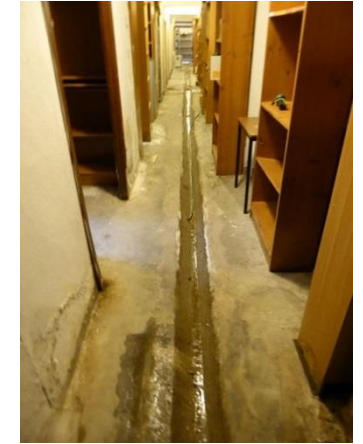
programme. There were no obvious defects or evidence of leak.			
Cellar 1	1771 Wing - Main Reception	Cellar in fair to poor condition and neglected in areas however there was no evidence of major defect. It was noted there appeared to be evidence of insect attack (woodworm) to timbers of the floor above. This should be inspected and verified by a timber preservation specialist. There was a duct with pipework. The duct was signed as containing asbestos. There was what appeared to be a neglected room assigned as use as a chapel. Generally the cellar area was in poor to fair condition.	Fair to poor	F/P	83 to 94
Cellar 2	1931 Wing	Cellar in fair condition. Evidence of ground water and remedial measures of gully and sump as expected for a building of this age and design. The cellar was reasonably dry and used as a book store. The dumb waiter which appeared decommissioned. Generally the cellar area was in fair condition.	Fair	F	95 to 99

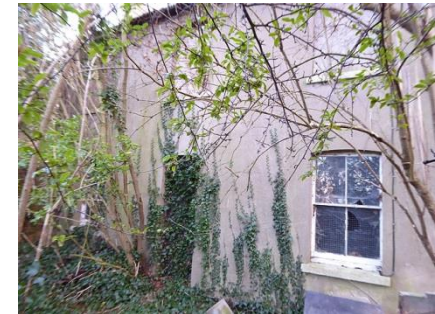
Pertinent Points – Grounds					
Item	Location / Element	Description	Condition	Condition Category	Photograph No
Grounds	Generally	<p>The grounds generally appeared in reasonable condition. Hard surfaces are generally well maintained and even. The vehicle parking area and vehicle access from Horton Road was tarmac. Remedial repair will be required in circa 1 to 5 years. It is recommended the area is inspected regularly to reduce risk of trip and fall.</p> <p>Grassed areas and areas of planting appeared well maintained.</p>	Fair	F	100 to 105
Out-buildings	Houses	<p>There are two residential scale detached buildings which form two houses. The buildings appeared neglected and in need of renovation. There is opportunity to utilise the buildings as administration or accommodation. It is suggested that further investigation as to their retention and refurbishment or replacement is considered. Sheds and utility buildings appeared in reasonable condition although possibly not in keeping with the portfolio.</p>	Poor to Fair	P / F	106 to 107
