# Precis Schedule of Condition

## Wotton House

Horton Road, Gloucester GL1 3PT

**Report Date: 4 February 2016**

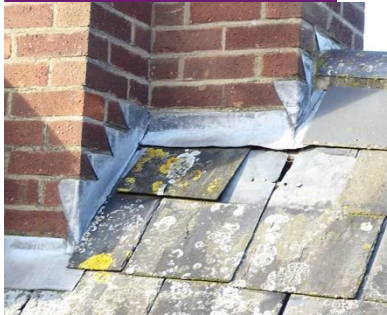
Item	Location / Element	Description	Condition	Condition Category	Photograph No
Chimneys	1771 Wing - Main Reception / Admin	Red face brick chimney in reasonable condition. Repointing will be required in circa 5 years. The roof appears in generally good order. Access for repairs is a consideration.	Fair	F	1 to 10
	1931 Wing	Red face-brick chimneys in reasonable condition. Repointing will be required in circa 5 years. A number of the chimneys have been repaired with new brickwork to upper courses.  The chimney to the lecture hall corridor is in poor condition and it is recommended allowance is made for repointing in circa 1 to 3 years.	Fair  Poor	F  P	1 to 10  1
Roof Areas	1771 Wing - Main Reception / Admin	Slate covered pitched roof fair condition. A small number of dislodged slates. Minor repairs required	Fair	F	11 to 13
	1931 Wing Lecture Hall	Slate covered pitched roof fair to good condition. Minor repairs required	Fair	F	11 to 13

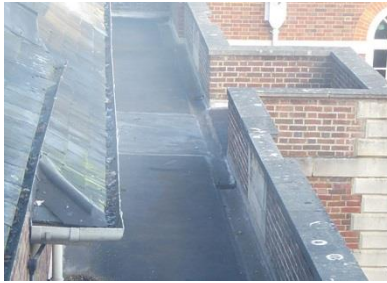
1931 Wing Corridor / Lecture Hall corridor	Flat roof asphalt in fair condition. There is evidence of water ingress to the north (front) of the corridor ceiling and walls. Water ingress appears to be from the abutment of the roof cover and the brick built parapet. Further investigation (during wet conditions) and remedial work is suggested.  There was a lantern light which appeared in	Poor	p	19 to 28

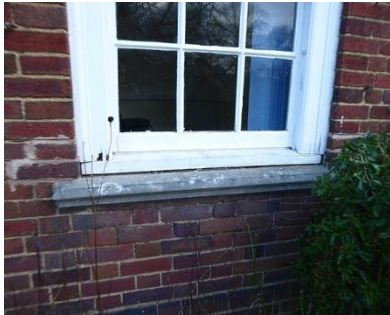
Rainwater pipes and gutters Main walls – external elevations	1771 Wing - Main Reception / Admin	There is what appears to be an original hopper dated 1707 and downpipe to the wing. Gutters are generally in fair condition. There is evidence of water damage adjacent to downpipes to the rear elevation. It is suggested allowance is made for overhaul of the gutters and downpipes to this area.	Fair	F	35 to 39
	1931 Wing	Gutters and downpipes to the 1931 wing generally appeared in fair condition. It is suggested allowance is made for minor repairs	Fair	F	
Windows	1771 Wing - Main Reception / Admin	Windows are timber framed single glazed sashes and casements. Generally in fair condition for the age and exposure of the building. Redecoration will be required in circa 1 to 3 years. It is suggested windows are overhauled during this time.	Fair	F	44 to 48
	1931 Wing	Windows are timber framed single glazed sashes and casements. Generally in fair condition for the age and exposure of the building. Redecoration will be required in circa 1 to 3 years. It is suggested windows are overhauled during this time. It is suggested redecoration is phased.  It was noted there was evident timber decay to a number of cills and sash window jambs and allowance will be required to address this	Fair  Fair	F  F	40 to 43  42

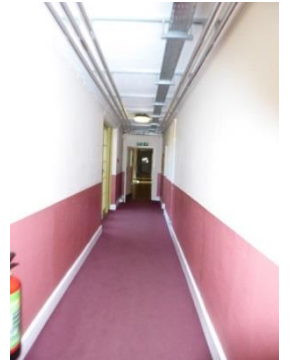
Walls and partitions	1771 Wing - Main Reception / Admin and 1931 Wing	Walls generally decorated plaster in good to fair condition. There was cracking to the wall stairs from the attic rooms. The cracking appeared historic and not a major cause for concern. All rooms appeared clean and well maintained.	Fair	F	64 to 65

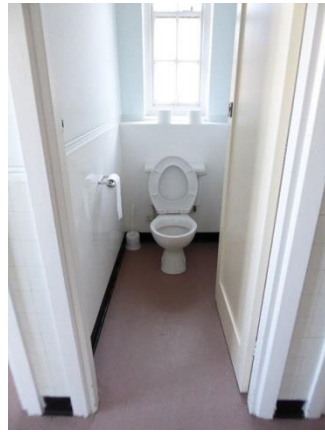
Sanitary fittings	1771 Wing - Main Reception / Admin and 1931 Wing	Sanitary fittings were in fair to good condition. It was evident there had been a refurbishment	Fair	F	71 to 74

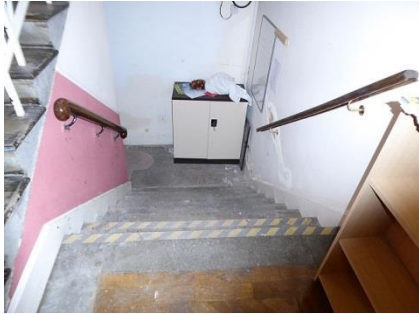
programme. There were no obvious defects or evidence of leak.			
Cellar 1	1771 Wing - Main Reception	Cellar in fair to poor condition and neglected in areas however there was no evidence of major defect. It was noted there appeared to be evidence of insect attack (woodworm) to timbers of the floor above. This should be inspected and verified by a timber preservation specialist. There was a duct with pipework. The duct was signed as containing asbestos. There was what appeared to be a neglected room assigned as use as a chapel. Generally the cellar area was in poor to fair condition.	Fair to poor	F/P	83 to 94
Cellar 2	1931 Wing	Cellar in fair condition. Evidence of ground water and remedial measures of gully and sump as expected for a building of this age and design. The cellar was reasonably dry and used as a book store. The dumb waiter which appeared decommissioned. Generally the cellar area was in fair condition.	Fair	F	95 to 99

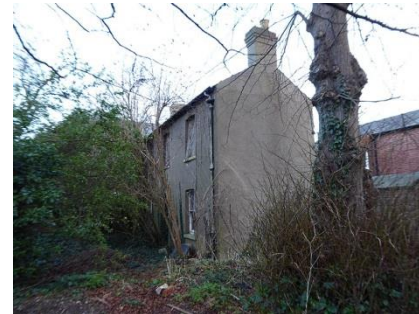
Pertinent Points – Grounds					
Item	Location / Element	Description	Condition	Condition Category	Photograph No
Grounds	Generally	<p>The grounds generally appeared in reasonable condition. Hard surfaces are generally well maintained and even. The vehicle parking area and vehicle access from Horton Road was tarmac. Remedial repair will be required in circa 1 to 5 years. It is recommended the area is inspected regularly to reduce risk of trip and fall.</p> <p>Grassed areas and areas of planting appeared well maintained.</p>	Fair	F	100 to 105
Out-buildings	Houses	<p>There are two residential scale detached buildings which form two houses. The buildings appeared neglected and in need of renovation. There is opportunity to utilise the buildings as administration or accommodation. It is suggested that further investigation as to their retention and refurbishment or replacement is considered. Sheds and utility buildings appeared in reasonable condition although possibly not in keeping with the portfolio.</p>	Poor to Fair	P / F	106 to 107
